**FAIRVIEW RESERVOIR DAM
CT 00205**

**PHASE 1 INSPECTION REPORT
NATIONAL DAM INSPECTION PROGRAM**

**DEPARTMENT OF THE ARMY
NEW ENGLAND DIVISION, CORPS OF ENGINEERS
WALTHAM, MASS.**

NOVEMBER 1978

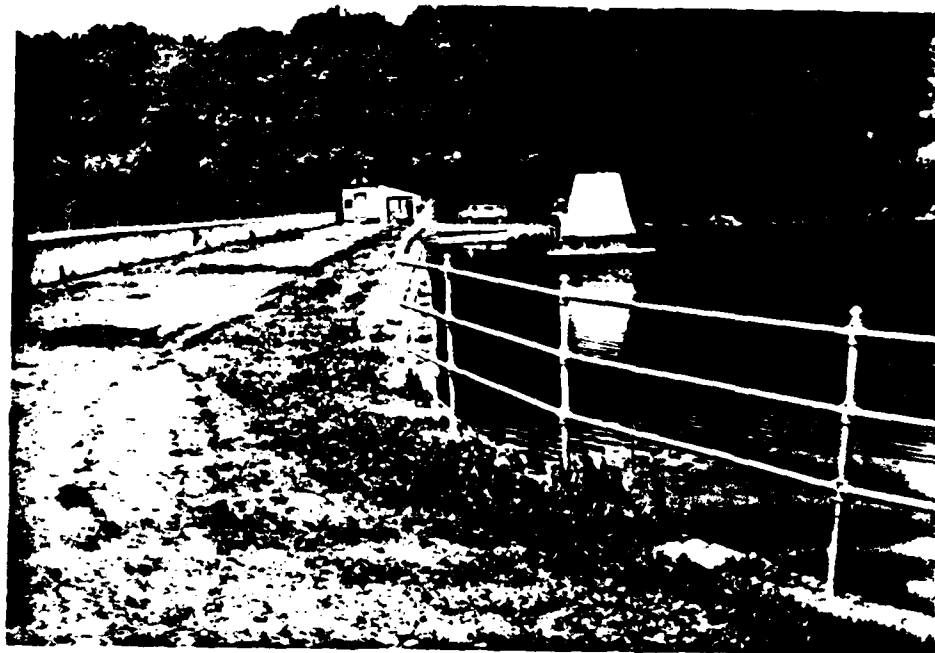
C-2 MAIN DAM-LOOKING FROM LEFT ABUTMENT ALONG
UPSTREAM FACE.

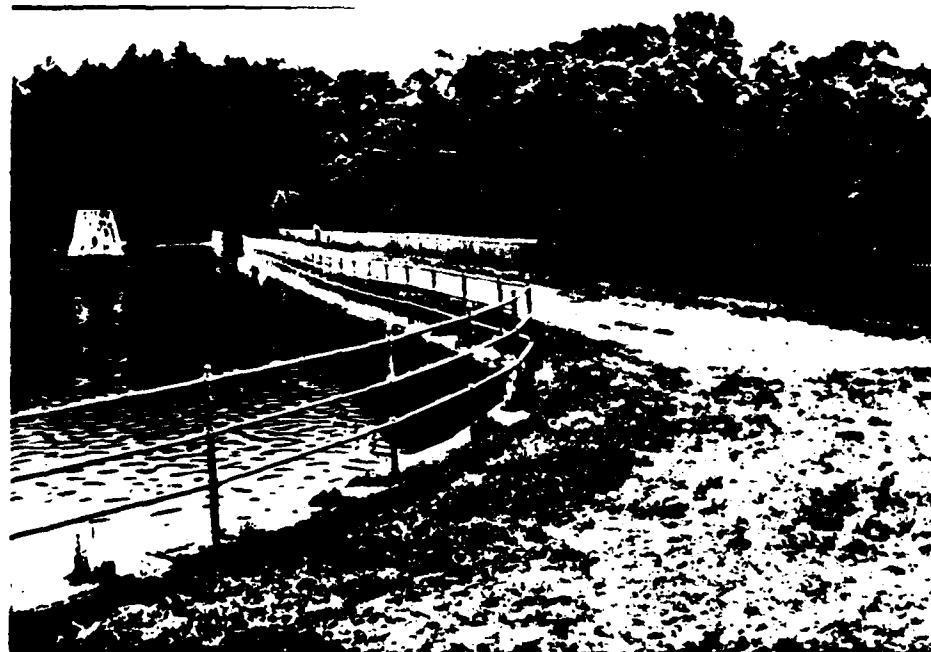
C-3 MAIN DAM-LOOKING FROM RIGHT ABUTMENT ALONG
UPSTREAM FACE. (NOTE: CURVATURE OF FACE AND RAILING.)

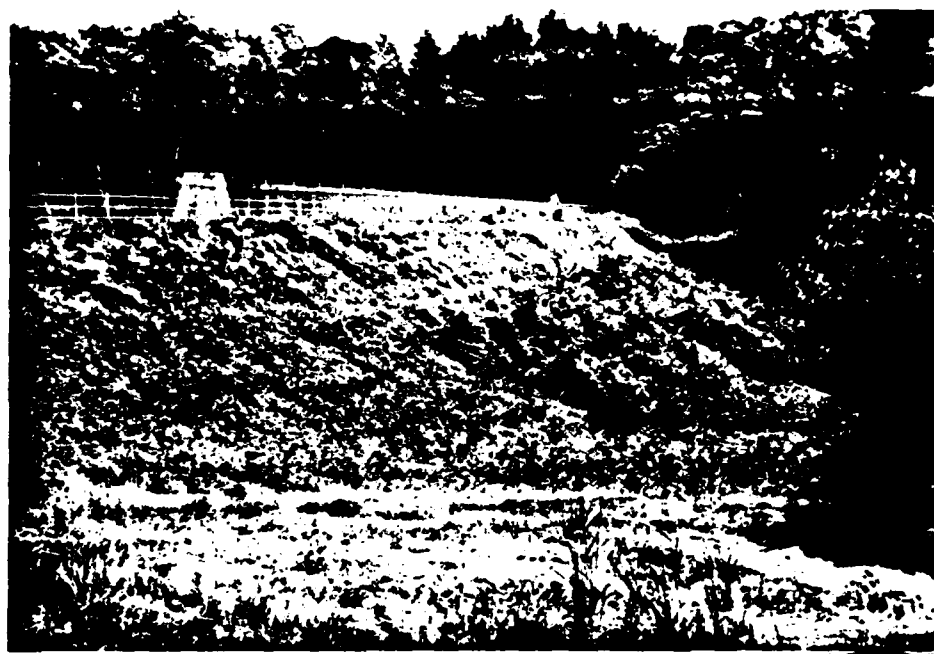
C-4 DOWNSTREAM FACE OF MAIN DAM

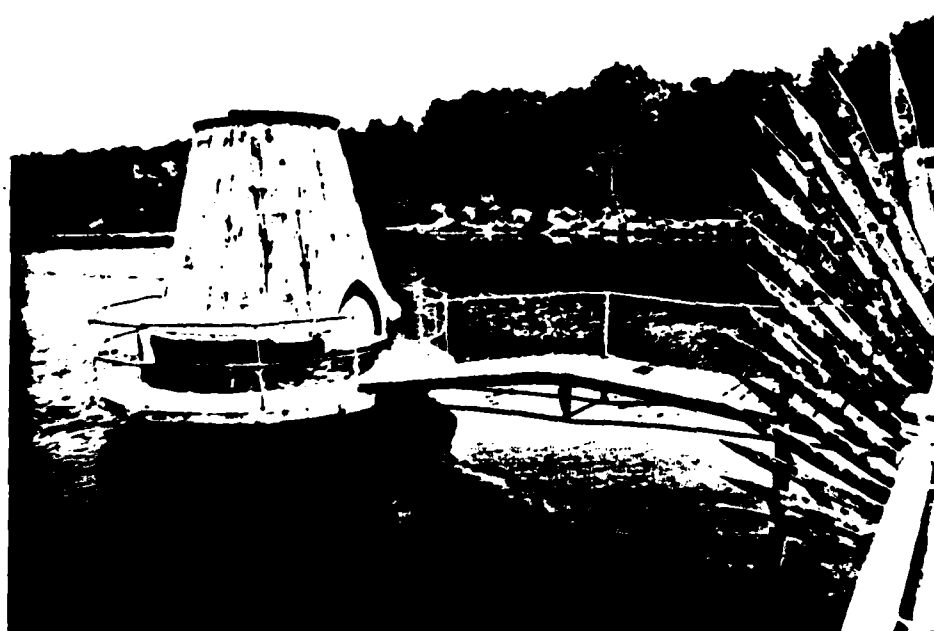
3. The outlet control structure is inoperable and should be restored or modified in order to control the outflow from the reservoir on the upstream side of the embankment. The wooden access bridge to this structure is in poor repair and should be replaced.

C-5 OUTLET CONTROL - TO SYSTEM

- e. Consider the renovation or replacement of the intake structure with a structure that will provide control of the outlet conduits from the upstream side of the dam. Initially, the wooden access bridge to the existing structure should be repaired and the structure secured to discourage vandalism.

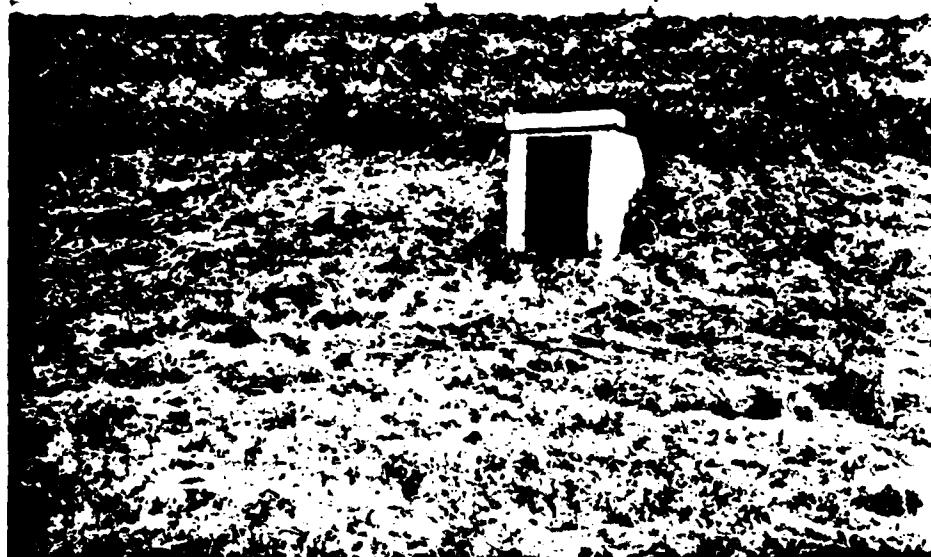
C-6 ENTRANCE TO VALVE CHAMBER AT DOWNSTREAM TOE OF
MAIN DAM

- f. Eliminate the problem of seepage in the valve chamber located at the downstream toe of the dam. Consideration may be given to filling the chamber with suitable material or completely eliminating or redesigning it.
- g. Determine the cause of and correct the seepage occurring beneath the spillway and repair the deteriorated spillway.

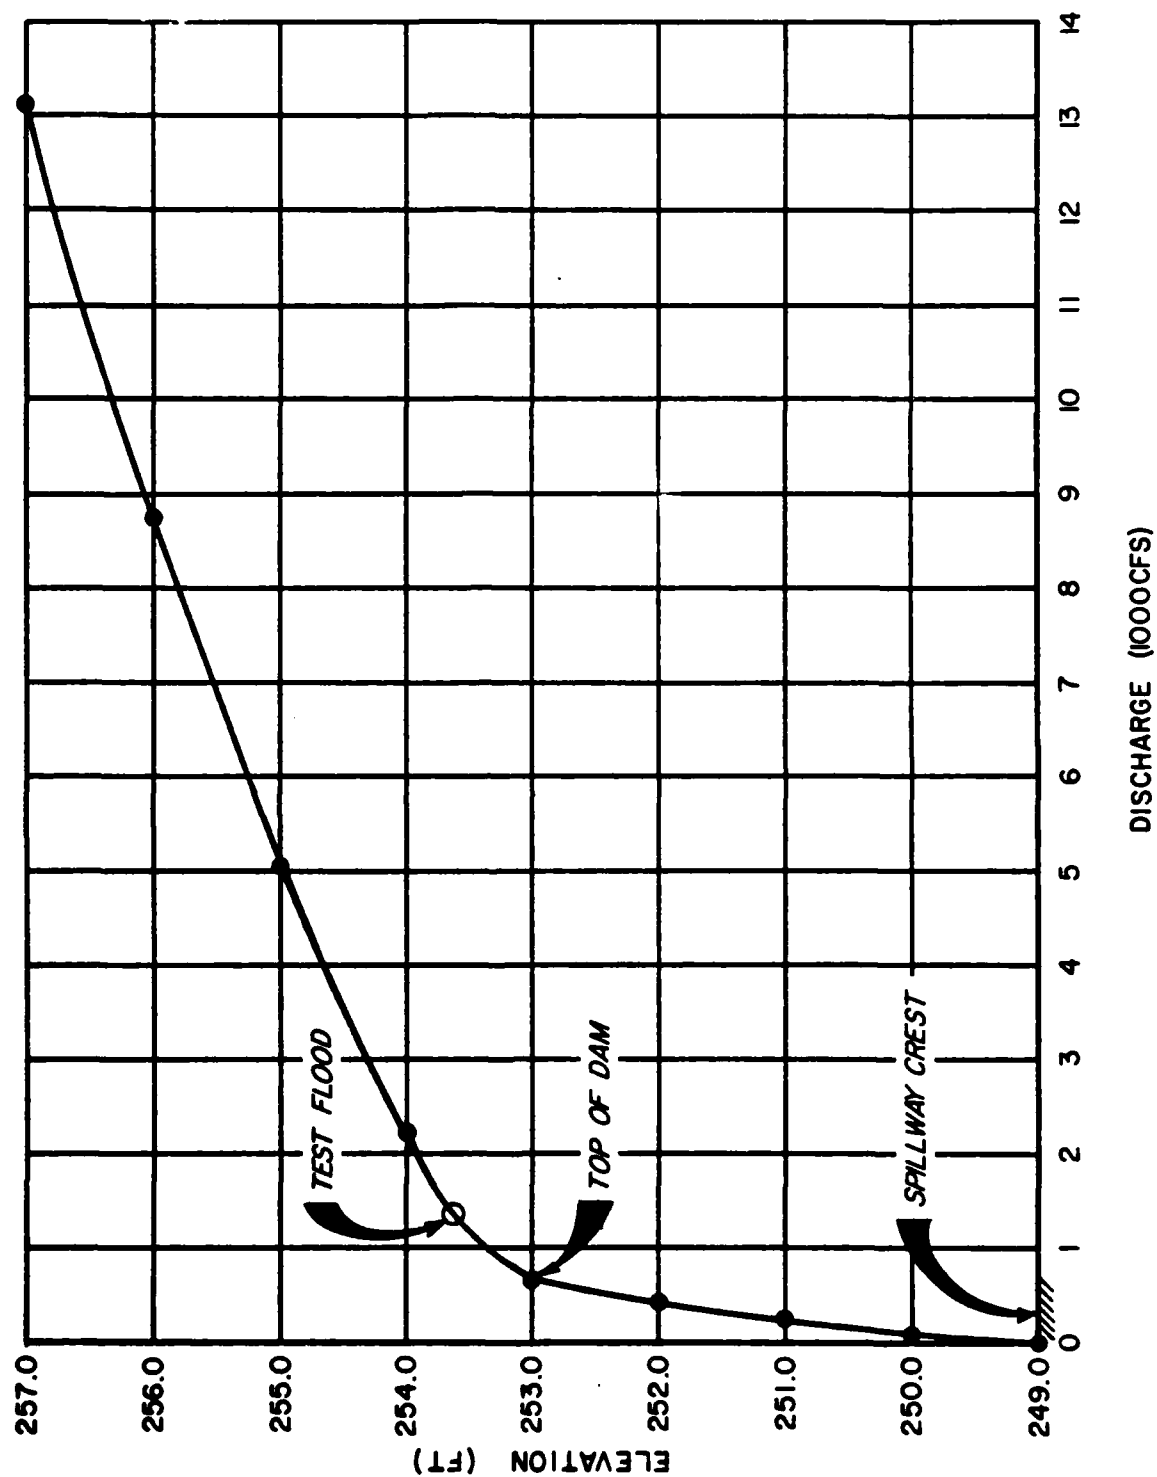
SPILLWAY RATING CURVE
FAIRVIEW RESERVOIR

The spillway is hydraulically inadequate to pass the "test flood" (PMF) and would overtop the dam approximately 0.66 feet (refer to Table on Page 24). The maximum outflow capacity of the spillway is 648 cfs; sufficient to contain the 100-year flood event within the spillway training walls with some allowance for freeboard. The spillway capacity represents 47.8% of the test flood. The test flood will produce an approximate water surface Elevation of 240.0 immediately downstream from the dam. This failure discharge will also produce a water surface approximately 8 ft. in depth near Scotland Road.
